Manhole Inspection Summary

Manhole # S45C2_014MH

Insp Date: **12/21/07 9:10 AM**

Location Address: **3801 Fairhaven Ave**

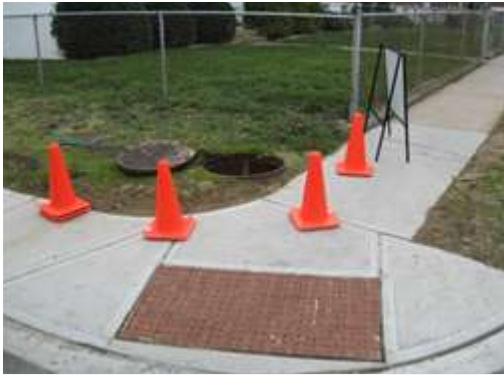
Location View

Fairhaven Ave.

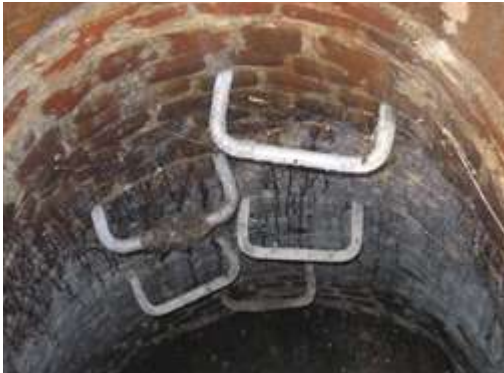
Steps Count: **5** Missing: **0** ☐ Corroded

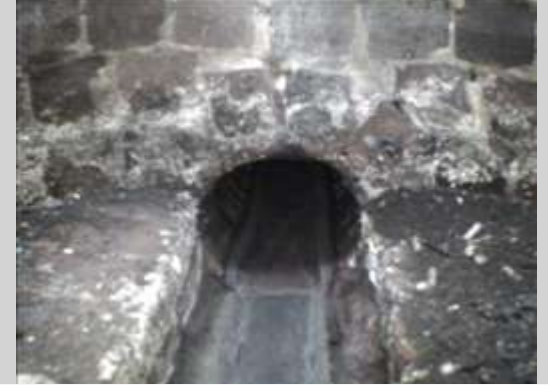
12 O'Clock Outflow

8 in. Circular Gravity Sewer
Pipe Out @ 12 O'Clock

Pipe Height: **10.8** (in.) Rod and Bar (Angled)
Pipe Material: **Clay** ☐ Pipe Lined
Invert Depth: **10.25** (ft.) Flow Characteristics: **Fast**
Deposits: ☒ None ☐ Mud ☐ Sludge ☐ Debris ☐ Grease
Silt Depth: (in.) Deposits Extent:
Infiltration: **None** Pipe Seal Cond: **Sound**

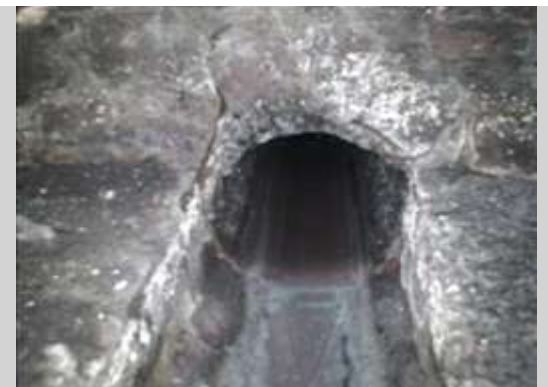
6 O'Clock Inflow

8 in. Circular Gravity Sewer
Pipe In @ 6 O'Clock

Pipe Height: **9.6** (in.) Rod and Bar (Angled)
Pipe Material: **Clay** ☐ Pipe Lined
Invert Depth: **10.17** (ft.) Flow Characteristics: **Fast**
Deposits: ☒ None ☐ Mud ☐ Sludge ☐ Debris ☐ Grease
Silt Depth: (in.) Deposits Extent:
Infiltration: **None** Pipe Seal Cond: **Sound**
